# Manhole Inspection Summary

Manhole # S19I1\_008MH

Insp Date: **4/22/08 1:31 PM**

**Location** Address: **3009 southdene av**

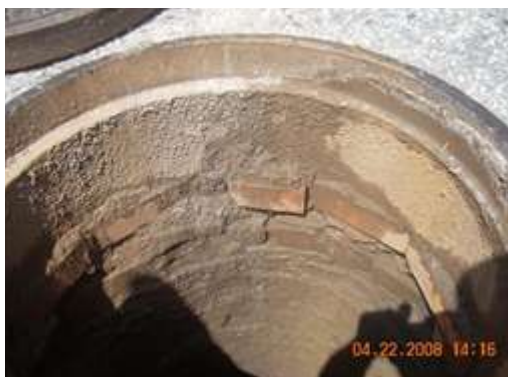
Defect 2

**Frame** Offset: **0** (in.) Condition: ☐ Sound ☐ Cracked ☒ **Leaks**

frame leaks-inflow evidence

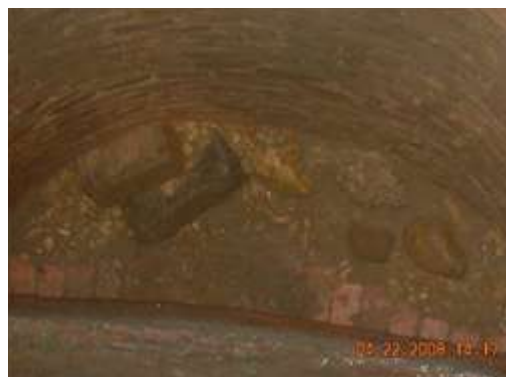
Defect 4

Condition: ☐ Sound ☐ Cracked ☐ Root Intrusion ☐ Deteriorated ☐ Leaks ☒ **Debris**

debris on bench

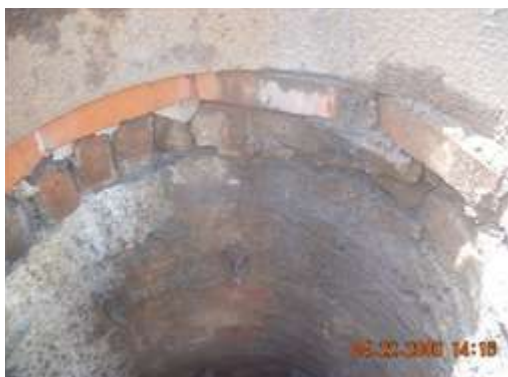
Defect 3

Infiltration: ☐ None ☒ **Joint** ☐ Cracks ☐ Mortar ☐ Roots ☐ Wall

infiltration @ chimney joint

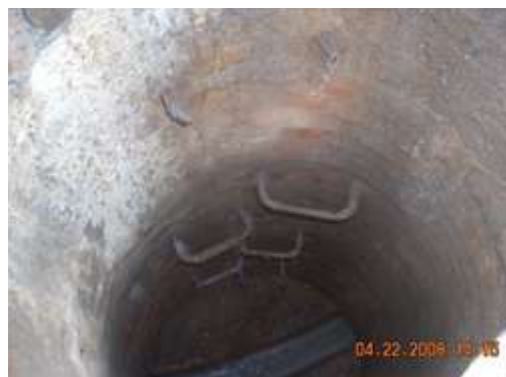
Defect 1

**Steps** Count: **5** Missing: **1** ☒ **Corroded**

corroded and missing steps

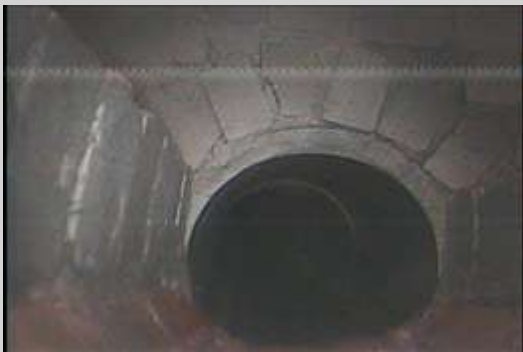
12 O'Clock Outflow

10 in. Circular Gravity Sewer  
Pipe Out @ 12 O'Clock

Pipe Height: **10.8** (in.) Rod and Bar (Angled)  
Pipe Material: **Clay** ☐ Pipe Lined  
Invert Depth: **11.95** (ft.) Flow Characteristics: **Fast**  
Deposits: ☒ None ☐ Mud ☐ Sludge ☐ Debris ☐ Grease  
Silt Depth: **0** (in.) Deposits Extent:  
Infiltration: **None** Pipe Seal Cond: **Sound**

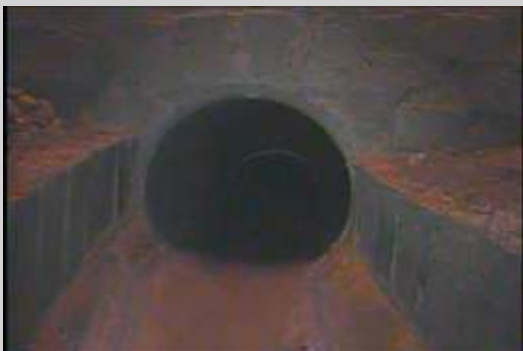
7 O'Clock Inflow

10 in. Circular Gravity Sewer  
Pipe In @ 7 O'Clock

Pipe Height: **10.8** (in.) Rod and Bar (Angled)  
Pipe Material: **Clay** ☐ Pipe Lined  
Invert Depth: **11.22** (ft.) Flow Characteristics: **Fast**  
Deposits: ☒ None ☐ Mud ☐ Sludge ☐ Debris ☐ Grease  
Silt Depth: **0** (in.) Deposits Extent:  
Infiltration: **None** Pipe Seal Cond: **Sound**
